U.S. Army  
Coast. Eng. Res.  
Ctr.  
MP 7-75  
(AD-A014 137)

# Evaluation of Potential Use of Vegetation for Erosion Abatement Along the Great Lakes Shoreline

by  
V.L. Hall and J.D. Ludwig

MISCELLANEOUS PAPER NO. 7-75  
JUNE 1975

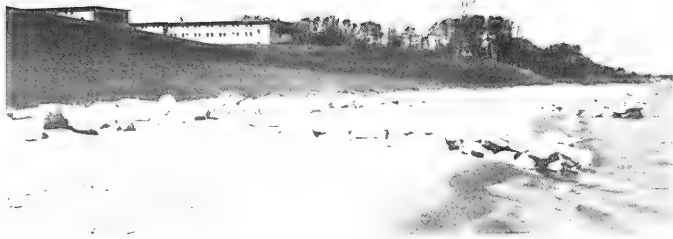
Figure 11. Reformation of rough bank (above) and landscaping of shoreline (below).  
(Courtesy of Soil Conservation Service.)

An example of a Lake Michigan shore modification is shown in Figure 11. The site was in Racine County about 3 miles north of Racine, Wisconsin. Rock was used for shoreline protection to minimize erosion of the embankment. The rough steep bank was graded to a more gentle slope and was seeded to control surface erosion. This shore front modification requires a soil that is not subject to seepage so severe that it causes bank failure. Loam soil is best for this type of reclamation. The best vegetative growth is obtained by topdressing with fertilizer and irrigating. Where a specific type of vegetation is desired, weed control may also be required. This shore front renovation requires constant management to maintain a turf appearance.
